# Clinical case report

## Closed Surgical Wound

Avance® Solo is a portable, battery powered, single use, negative pressure wound therapy (NPWT) system. It shares fluid management between an absorptive multi-layered dressing (Avance Solo Border with Safetac® adhesive to minimise trauma to the wound site and surrounding skin on removal). It has a 50ml canister that is easily replaced by carers and patients. The system delivers -125mmHg continuous regulated negative pressure for up to 14 days and is intended for use on closed incisions and chronic wounds. It also features both audible and visual alarms to facilitate efficient and timely restoration of therapy.

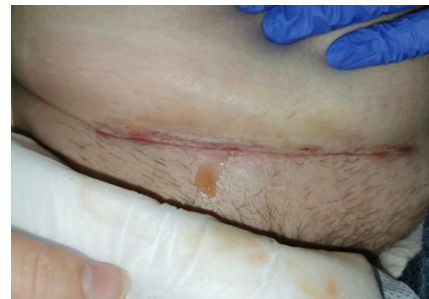
#### Treatment day 1

*A 9-day-old infected surgical wound with high levels of serosanguinous/blood, non-viscous exudate. The peri-wound skin was healthy, but showed signs of erythema and induration.*

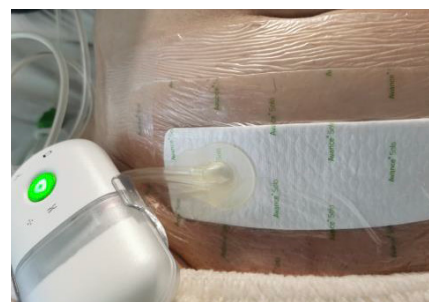
*Avance Solo was applied to the wound.*

- At the baseline assessment, the wound was cleansed with a hypochlorus acid wound irrigaton solution.
- An Avance® Solo Border absorbent dressing was placed over the incision site before being attached to the Avance Solo NPWT pump with canister.
- After 3 days, an unscheduled dressing change was required as the patient was anxious believing there had been an ingress of water into the system. On inspection, no water was present in the canister. The wound was re-dressed and remained in situ for a further 8 days.
- Dressing changes were performed according to the local clinical practice.

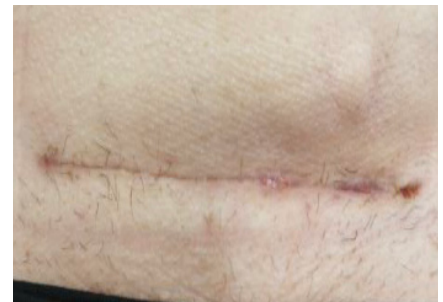
### Final evaluation (treatment day 11)

*The incision wound had healed. Induration of the surrounding tissue was further improved.*

- At the final evaluation, the wound had healed.
- The clinician considered the Avance Solo NPWT system to be easy to use. He commented "The pump is a good size and, having the canister and absorbent dressing together, is a great point of difference which increases the capacity for fluid management when required. The pump's motor is quiet, however the intermittent pumping for the feedback system can be disturbing especially at night.\* The dressing remains in place well, and it has great absorbency and wicking abilities. Its narrow border ensures it is not too obtrusive beyond the wound size".
- The patient found Avance Solo to be comfortable and was pleased with the supportive nature of the dressing. She was very happy at the quick resolution of her wound issues.
